Technical Report CERC-95-3
March 1995

Periodic Inspection of Cleveland Harbor East Breakwater, Ohio

Report 1 Base Conditions

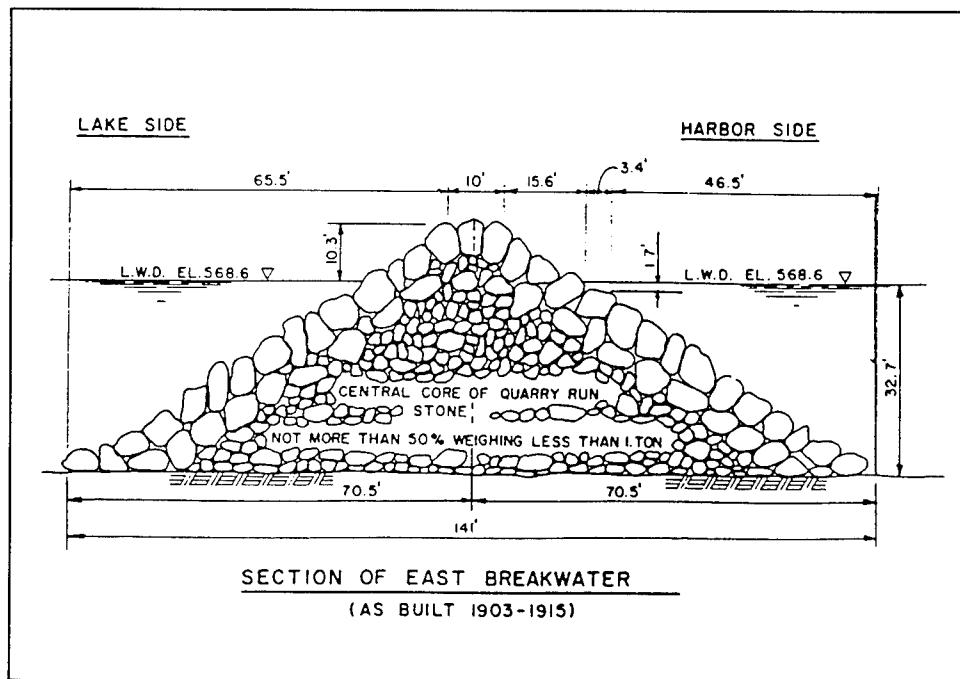
Figure 5. Cross section of eastern 20,070-ft portion of Cleveland Harbor east breakwater as originally constructed

consisted of dumped core stone covered with large individually placed armor stone (Figure 5). The breakwater has a design crest elevation (el)¹ of 3.14 m (+10.3 ft) and a crest width of 3.05 m (10 ft). The side slopes were constructed with 1V:1.5H slopes. A U.S. Coast Guard lighthouse is located at the easterly end of the breakwater at its head. It was constructed on a 6.4- by 6.4 m (21- by 21-ft) square concrete footing. Depths on the lake side of the structure range between -9.1 and -10.7 m (-30 and -35 ft). Depths are more shallow on the harbor side due to natural accretion of sediments within the harbor since construction.

The east breakwater has had an extensive repair history (Bottin 1988). Storm damage has caused the displacement of laid-up cover stone, especially on the lake side, resulting in the continuous unravelling of the breakwater slope in many areas. Some deterioration and loss of individual cover stone had also resulted in exposure of the underlayer core stone. Subsequent loss of core stone during storm conditions has resulted in further deterioration of the structure and some sections have collapsed. The structure's integrity has been adversely affected in the zone from -3.05 m to +3.14 m (-10 ft to +10.3 ft). Most of the structure damage was on the lake side with eventual deformation

Repairs to the structure, historically, were made by rebuilding the damaged portion above 3.05 m (10 ft) in a manner similar to the original construction using 2,722- to 7,257-kg (3- to 8-ton) stone. Below -3.05 m (-10 ft), additional stone weighing between 9,072 and 12,700 kg (10 and 14 tons) was randomly placed on the existing cover stone to help provide a base for the upper slope. Repairs were made to the east breakwater in 1927, 1928, 1930, 1932-1934, and 1946-1978. During the period 1965-1978, maintenance on the breakwater involved repairs to about 2,438 lin m (8,000 lin ft) at an expenditure in excess of \$8,000,000.

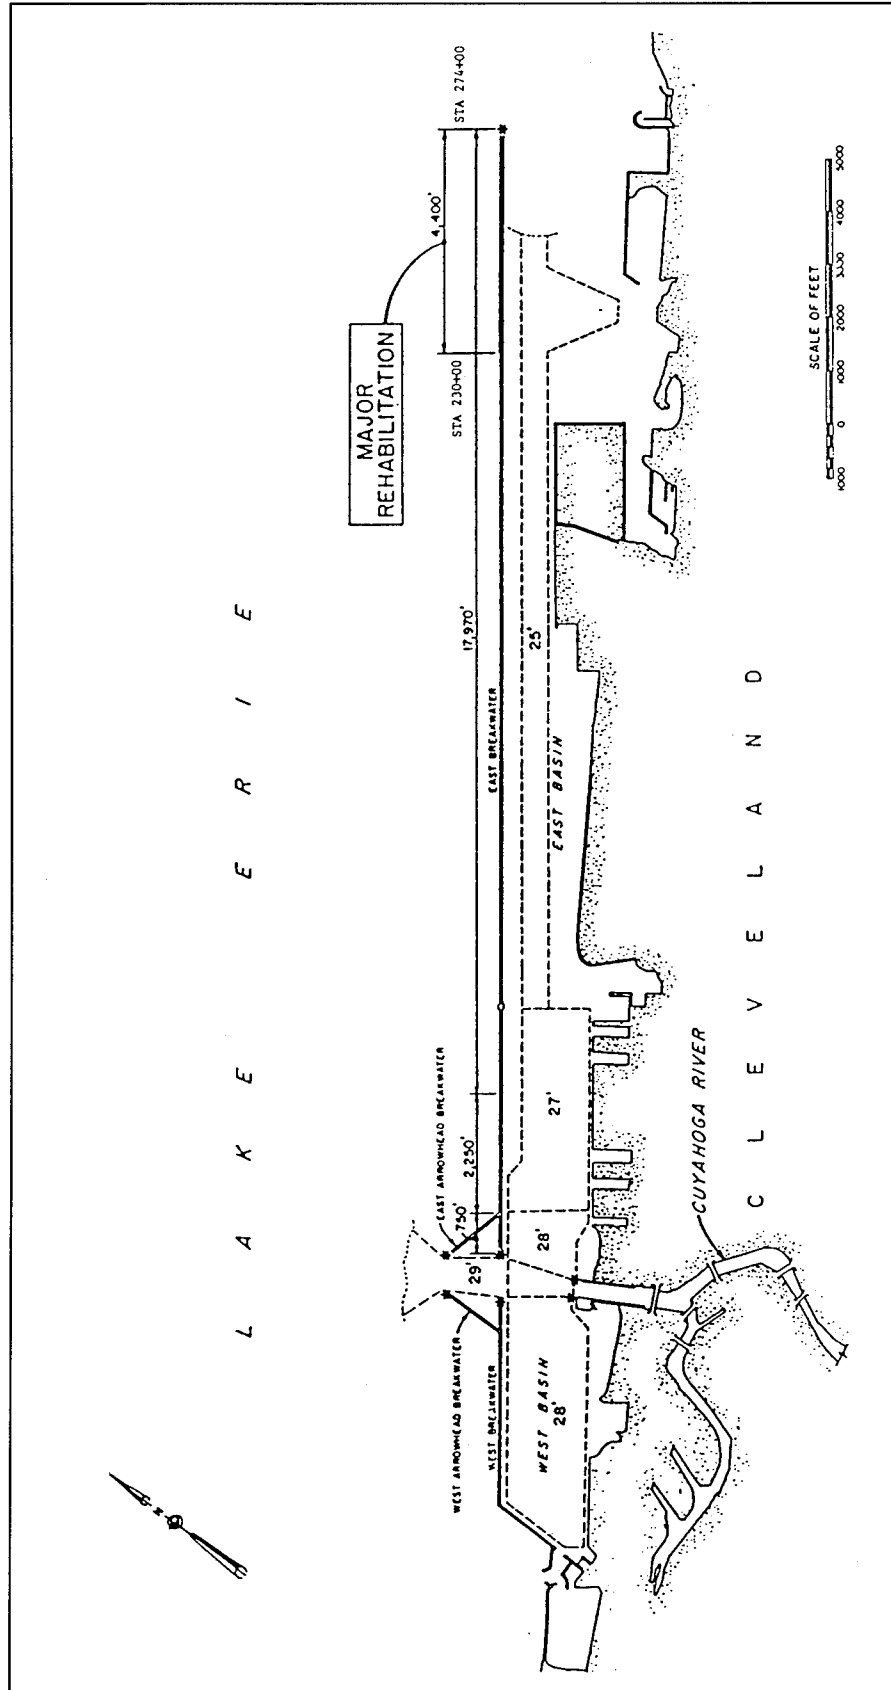
Figure 6. Major rehabilitation of east breakwater completed in 1979

A major rehabilitation project involving the easterly 1,341 m (4,400 ft) of the east breakwater was completed in 1979 (Figure 6). It involved repairing the structure with dolos concrete armor units. The lakeward slope, and in some areas the crest, were rebuilt using 1,814 kg (2-ton) dolos placed on a 1V:2H slope on the breakwater trunk. A typical section of the rehabilitated breakwater trunk is shown in Figure 7. The east head involved a section similar to the trunk but the slope was constructed on a 1V:2.5H to maintain stability. More information on the design of the dolos rehabilitation can be obtained from U.S. Army Engineer District, Buffalo (1979). The rehabilitated dolos section was monitored under the MCCC program and is discussed in Chapter 2. Additional dolosse were placed on the head section in 1982 and 1987 to repair storm damages.

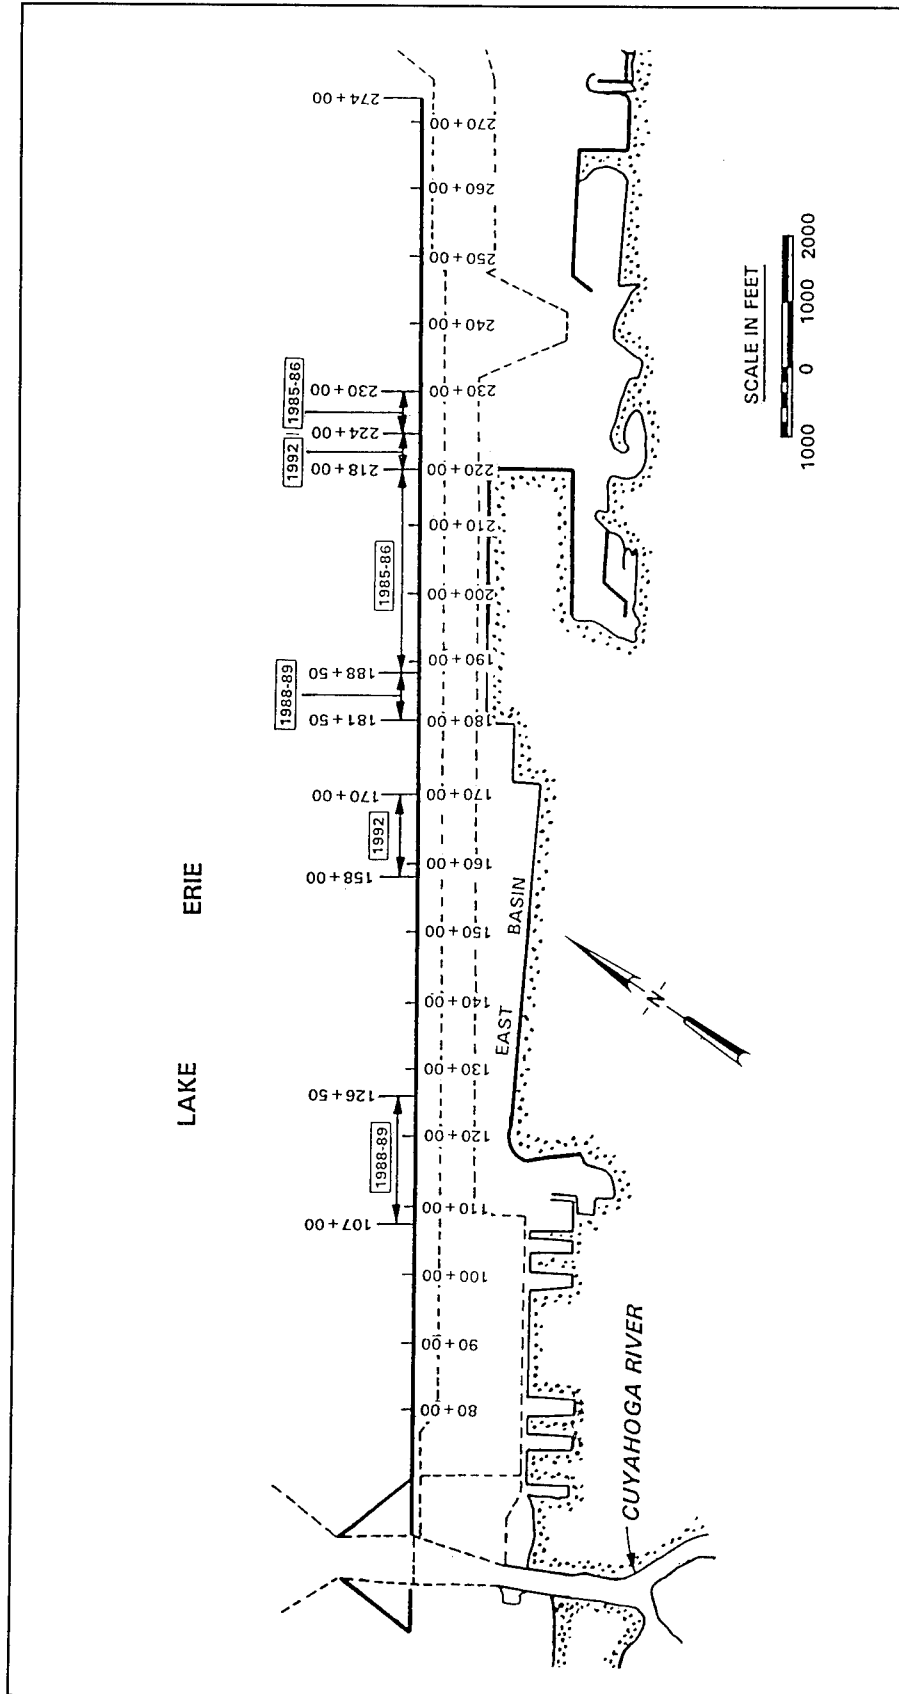
Figure 14. Major stone rehabilitation areas of the east breakwater from 1985-1992

The latest major stone rehabilitations of the Cleveland Harbor East Breakwater occurred in 1985-1986, 1988-1989, and 1992 as shown in Figure 14. The 1985-1986 rehabilitation (sta 188+50-218+00 and 224+00-230+00) involved the placement of 8,165 to 18,144-kg (9 to 20-ton) stone on 1V:1.5H side slopes. A walking inspection of the project in 1988 revealed extensive fracturing of the armor stone placed just three years earlier (Marcus 1993). Breakage of the stone was attributed to blast fractures and the geologic composition of the quarry. As a result, an intensive quality assurance/quality control effort was implemented prior to the 1988-1989 rehabilitation, which consisted of the same size stone and side slopes at sta 107+00-126+50 and 181+50-188+50. The 1992 rehabilitation entailed the installation of 3,900 to 8,709-kg (4.3 to 9.6-ton) stone on 1V:2H side slopes at sta 158+00-170+00 and 218+00-224+00.

Initially, three study reaches on three uniquely different stone rehabilitation sections of the Cleveland East Breakwater were selected for monitoring. Detailed geologic stone cracking investigations began at study Reach 1 (sta 197+65-198+65) in 1989. This section was representative of severely cracked stone rehabilitation work completed in 1985-86. In 1990, study Reach 2 was added to the project (sta 107+50-108+50). This section was constructed with the same size stone and delivered by the same supplier as Reach 1; however, this stone was placed only after passing an enhanced Government quality control/quality assurance (QC/QA) operation. In 1992, study Reach 3 (sta 164+00-164+55) was added to the program. This portion of the structure was constructed with smaller stone on a flatter slope with the intention of improving stone durability. The locations of all three study reaches are within the rehabilitation areas shown in Figure 14.

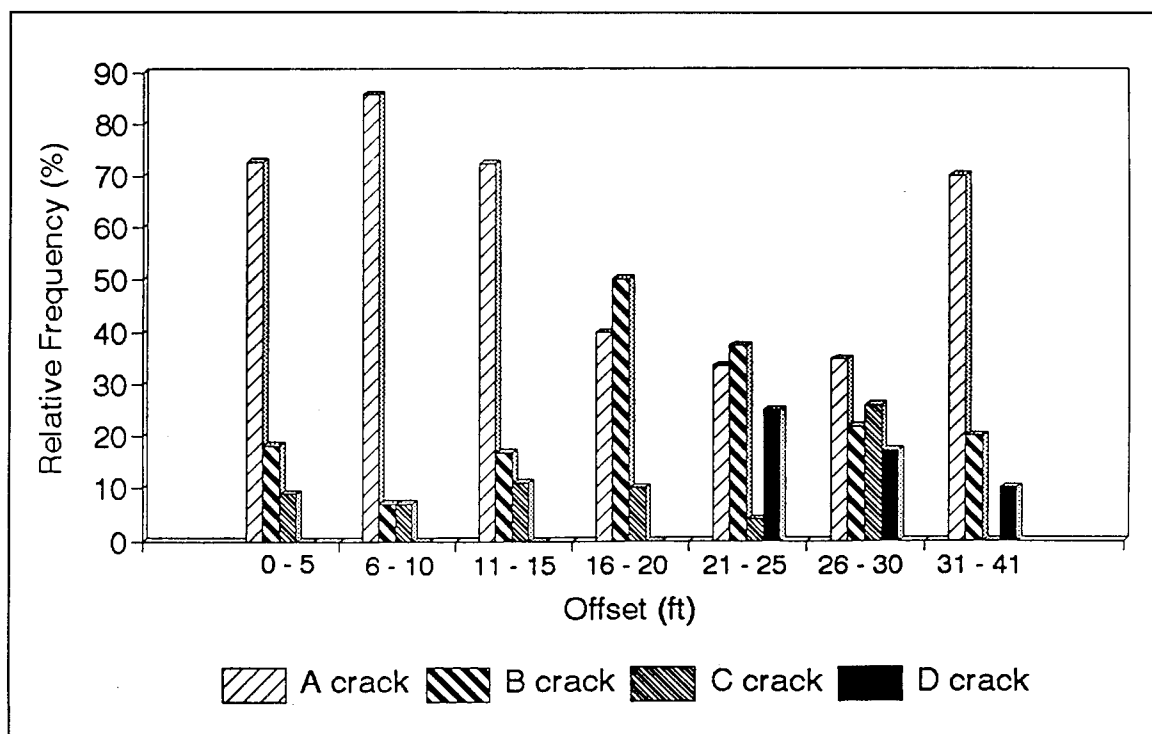
Figure 18. Relative frequency crack damage-type distribution versus offset distance from baseline

Study Reach 1 (sta 197+65-198+65) has been monitored annually throughout the project and is the best documented of the three study reaches. The Reach 1 evaluations reveal that of 59 stone armor units monitored between 1989 and 1992, random cracking is occurring across the entire profile of the breakwater reach (Figure 17). However, the relative frequency of the crack damage-type is largely skewed to the lakeside of the structure (Figure 18). Over the four years of monitoring, the worst damage classification, type "D," is occurring at or near the waterline. The number of significant cracks has increased with time on both damaged and undamaged stones. Of 12 good stones documented in 1989, two became significantly damaged by 1992; one cracking in each of the 6th and 7th years of exposure. The degree of damage change was highest between 1989 and 1990, likely due to increased storm frequency and duration compared with later years. The apparent mechanism for cracking is about half blast related and half natural. Of 93 cracks documented in study Reach 1, 49 were recorded as blast related (53 percent), and 44 cracks (47 percent) were apparently caused by natural consequences such as freeze-thaw, wet-dry, or other weathering factors. At the end of monitoring in 1992, 83 percent of the stones on study Reach 1 was documented as being cracked.

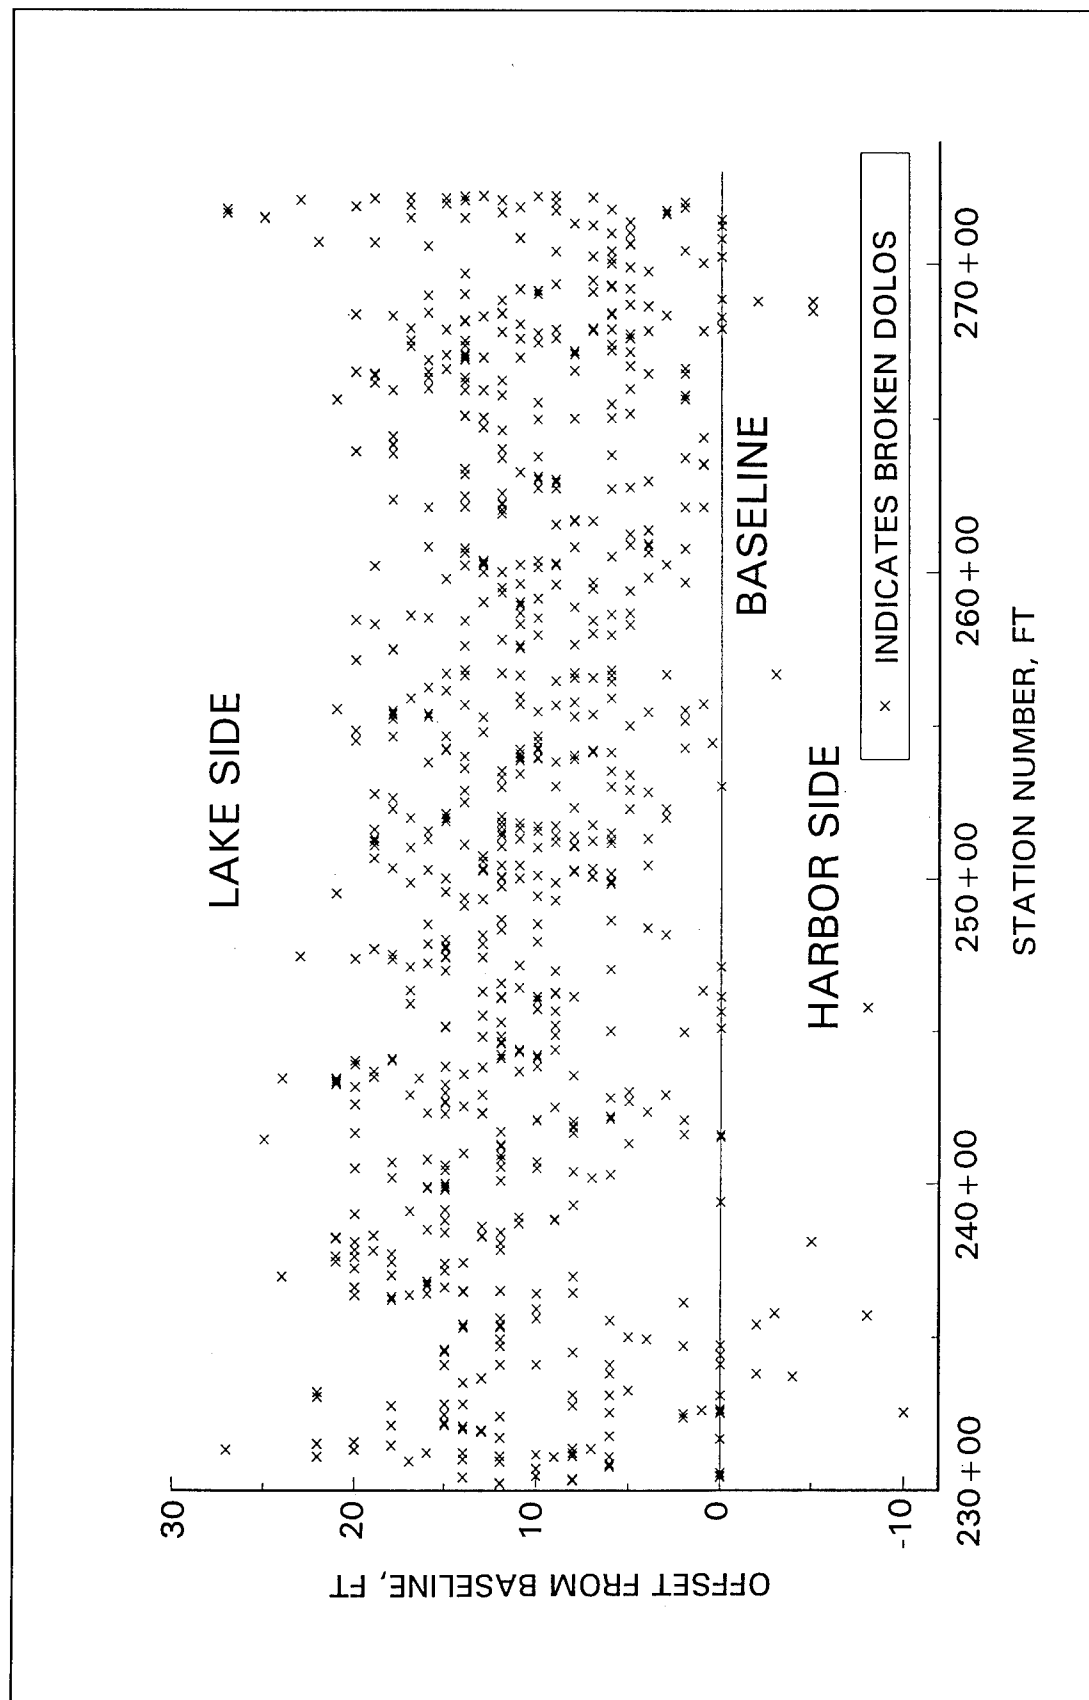
Figure 25. Distribution of broken dolos armor units along breakwater trunk relative to station number

Evaluation of the survey results indicates 782 broken/ cracked dolos above the waterline. Eighteen broken units were observed around the east breakwater head with the remaining units along the trunk. Of the 18 broken/cracked armor units identified at the head, four were 3,628-kg (4-ton) dolos. Three additional broken 3,628-kg (4-ton) units were observed along the breakwater trunk. The distribution of broken dolos along the breakwater trunk as a function of station number and offset from the baseline was analyzed. (The baseline was approximately the lakeward edge of the existing capstone along the breakwater crest.) Figure 25 shows the locations of broken/cracked dolos relative to the station number. As shown, broken units occur along the entire trunk section and are not, in general, concentrated in any one particular area. The distribution of broken/cracked armor units relative to offset from the baseline is shown in Figure 26. The majority of the broken dolos along the breakwater trunk (80 percent) are located between 1.8 and 6.1 m (6 and 20 ft) lakeward of the baseline. These units are in the active wave zone. Comparison of broken units to production data indicated that no particular production group had an unusual amount of breakage.
